# The Consuta Trust

## *Consuta Trust Newsletter - Summer 2018*

### **Refurbishment work**

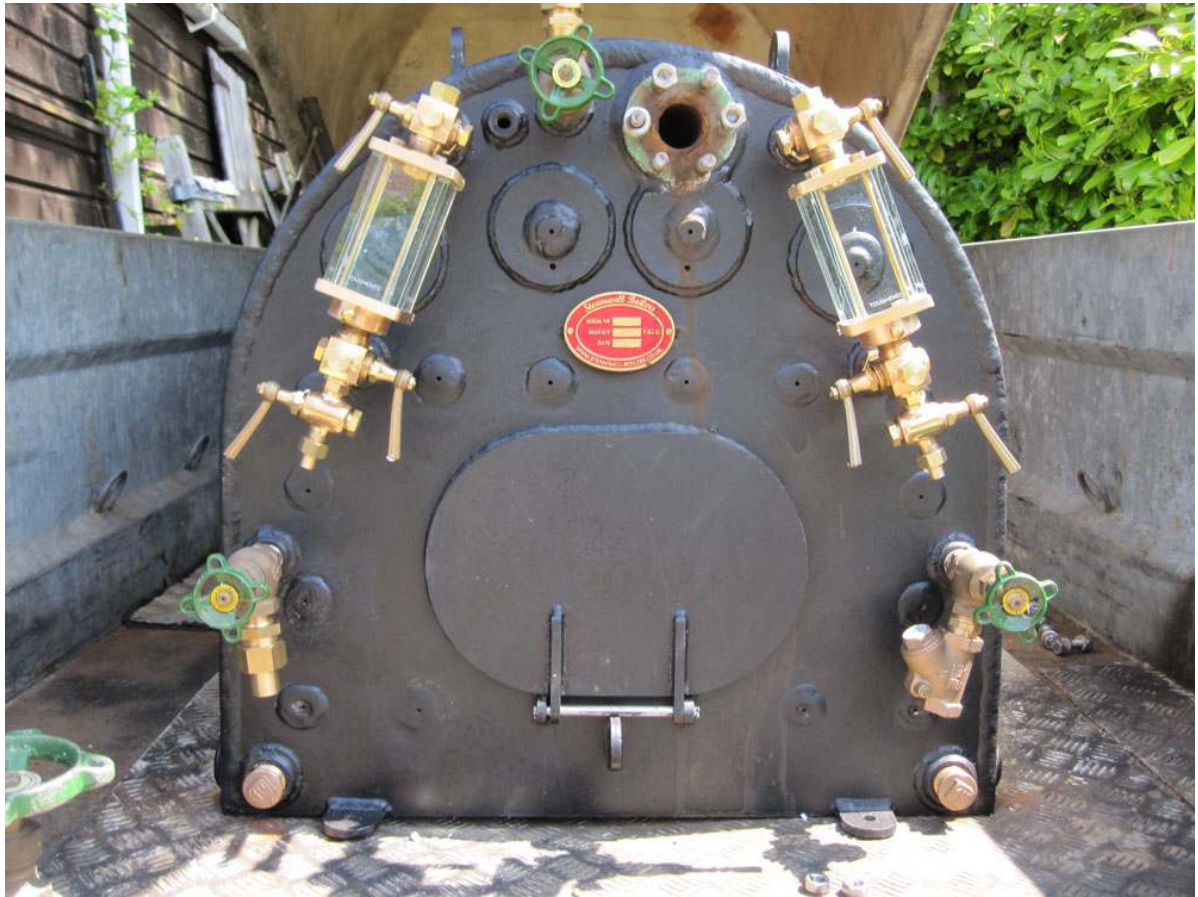
*Trying out some of the new fittings on the boiler, Note the main steam take off is from the backhead. The new boiler was subjected to a hydraulic pressure of 360 psi held for 45 minutes while the inspector looks for any sign of weakness or leakage.*

*The inset below shows a 400 psi gauge used to check pressure being applied by the hand pump.*

Due to a mix-up by the SBA Services boiler inspection service, we had to repeat the hydraulic test on the new boiler at Kintbury. A hydraulic test for a new boiler requires the boiler to be completely filled with cold water then pressurised to (in our case) twice maximum working pressure. For us this was a test pressure of 360 psi, applied and held for 45 minutes while the SBAS inspector checks for any signs of distortion, or any leakage from the welds or stays. There were no problems at all, so this means that the boiler will now only need all the new steam fittings mounted and then be checked out in steam at normal working pressure of 180 psi, this will be some time next year.

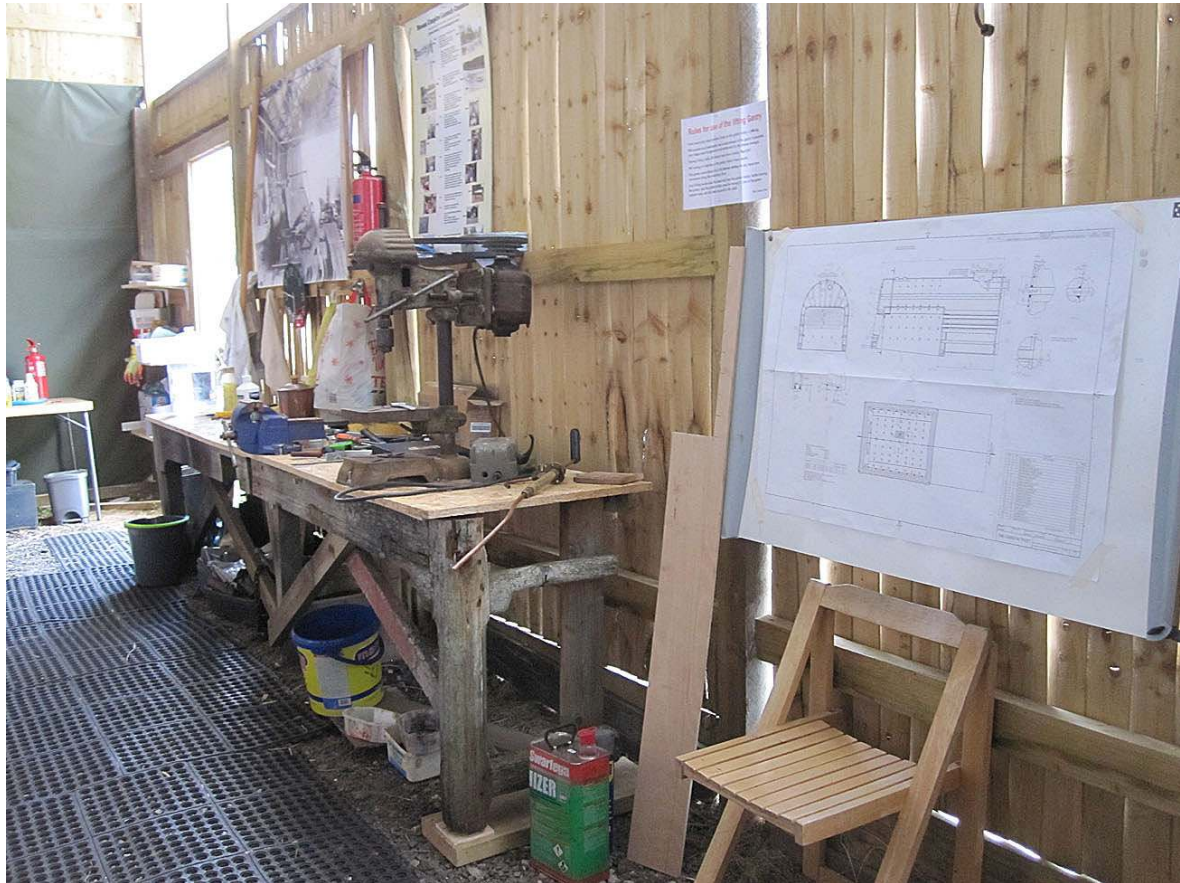
*Above, our two work benches, plus an old drilling machine not used so far.  
Below a general scene showing Consuta with SL Cygnet in the foreground and two sections of a stitched Saunders hull named Ullula standing vertical on the left.*

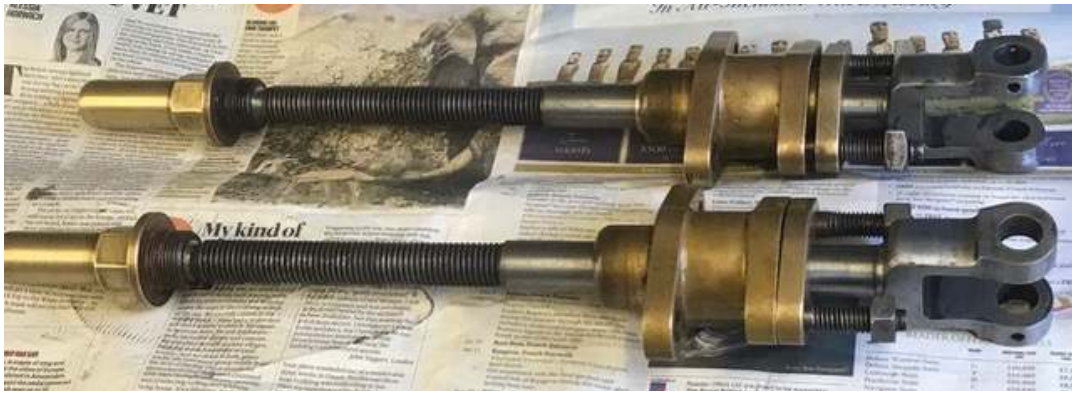
*Several supporters have taken parts away off site for cleaning or refurbishment.*

*Above are the two valve rod assemblies*

We had also decided to give the engine a major a check-up, a cleaning and repaint. This involved scraping off all the old caked-on oil and grime, cleaning all the brass bits and the wood lagging. Work was also needed to rectify the worn valve rod bushes. It seems that this had been done in the past so the rods

were reground and the worn bushes replaced, John Emmett kindly completed this work.

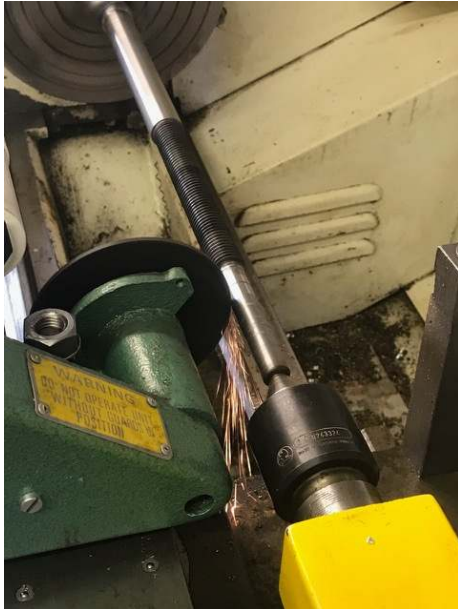
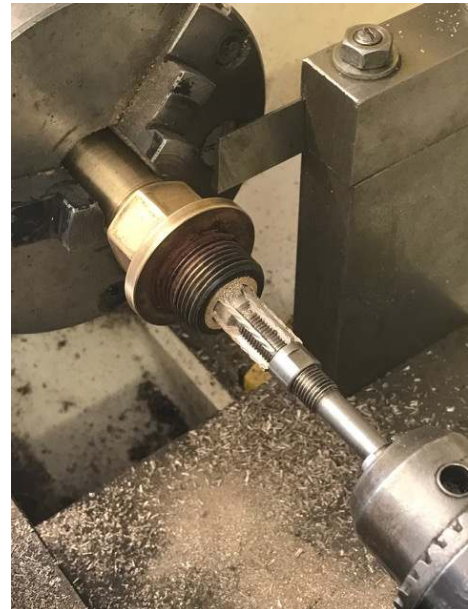
*The photos on each side show the work regrinding the engine valve rods, and reamering the engine top rod support.*

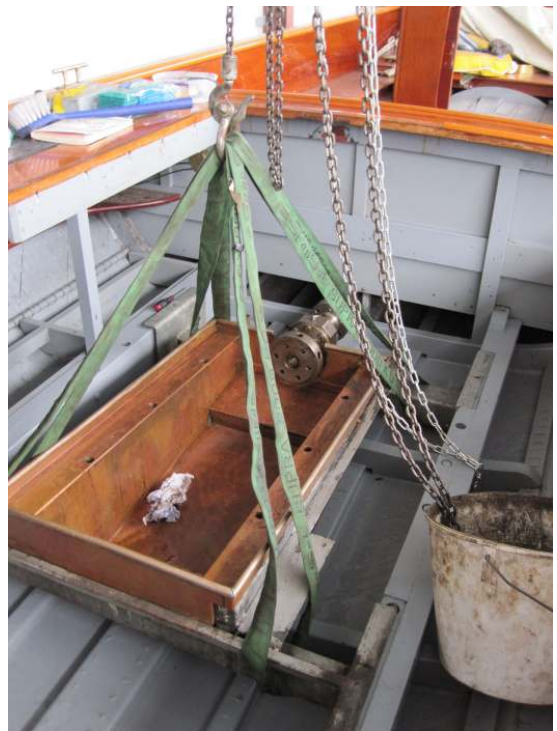
*The engine weighs about 657 lbs.*

*Surprisingly the engine mounting frame which includes the engine oil drip tray and thrust block weighs 183 lbs – now that is heavy!*

The lifting gantry has proved extremely useful and with our weighing gauge we find that the engine only weighs 657 lbs but the engine metal mounting frame which sits on the boiler bearers weighs over 180 lbs. The engine and the mounting frame have been taken out a couple of times. This was necessary to clean and repaint the bilge's under the engine, first time in 18 years, also to clean and repaint the engine.
